Analysis of the causes of the crash of Flight MH17 (Malaysian Boeing 777)

1. The Event

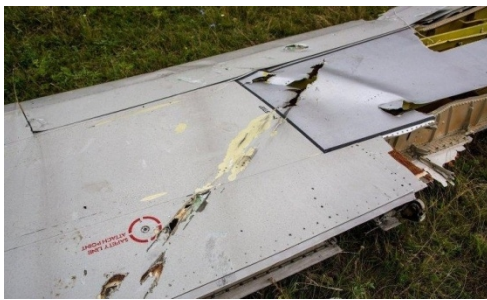
Picture 1. Fragment of the Boeing 777 plane
Фото 1. Фрагмент плоскости Boeing 777

Of particular note are the holes folded inward in the fuselage. They are round-bored, and usually grouped. Such holes can only be formed by metal objects with a circular cross-section, possibly rods or shells from an aircraft gun. The question arises: who could deliver such projectiles to the aircraft, by what means, and what might they look like?

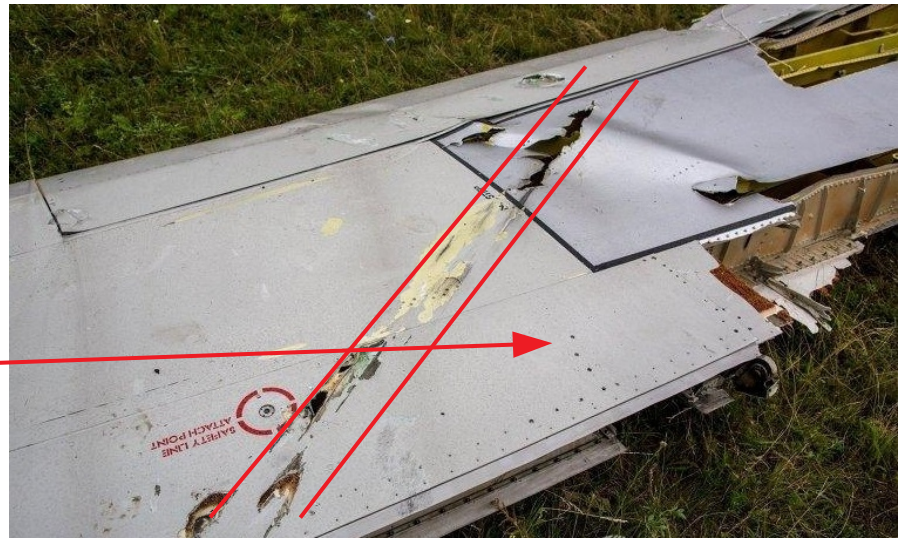
Photo 19. Damage to the flat surfaces of the Boeing 777
Фото 19. Повреждения плоскости Boeing 777

It would be logical to assume that the damage shown in photo 19 is more commonly associated with aircraft cannon shells of the GSH or SPPU type.

Damage to the Boeing 777 is not characteristic of the SAM "BUK-M1" missile

The general typology of the holes and their location suggest that is most likely the Boeing 777 was fired on using a GSh-2-30 aircraft cannon or an SPPU-22 container with dual-barrel 23-mm GSh-23L cannons: sighting was targeted in the area of the cockpit; while the shells that broke through the cockpit proceeded out the other side and caused damage to the flat surface of the wing (see photo 20). Both types

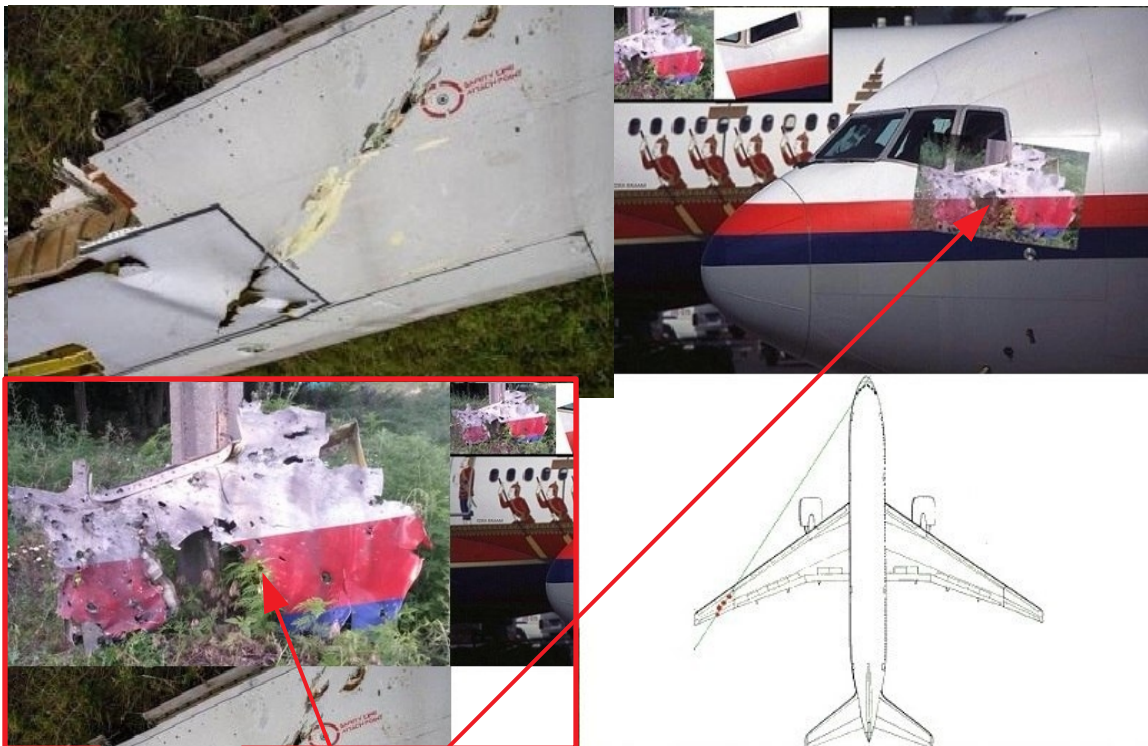
Photo 20. The nature of the damage to the cabin of the Boeing 777
Фото 20. Характер повреждений кабины Boeing 777

The picture of the entry and exit holes in the cockpit of the Boeing 777 are fully consistent with the passage through the flight of shells from the 20-30 mm caliber guns found on military aircraft. This confirms the second version of what brought down the Boeing. This is further supported by the way the puncture holes are

dispersed along the surface of the aircraft. The edges of the fragment of the fuselage from the left side of the cockpit are folded from the inside outward, which indicates that a significant blast occurred within the cockpit as a result of the dynamic impact of the shells on the right side.

On the trim panel the characteristic entry holes are visible as well as some exit points. The edges of the holes are bent inward; they are much smaller and are circular in shape. The exit openings are less clearly formed; their edges are torn outward. In addition, it is clear that exit holes broke through double aluminum lining and tilted it outward. That is, the strike elements ([judging] by type of impact - aircraft cannon shells) punched right through the cockpit. The open rivets were also bent outward.

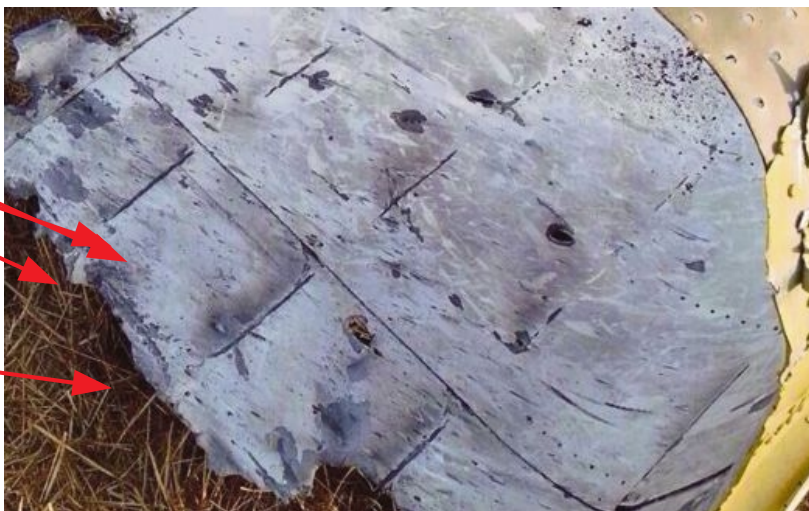
Photo 21. nature of the damage skin Boeing 777
Фото 21. Характер повреждений обшивки Boeing 777

A fragment of the Boeing 777. Clearly seen are the entry holes in the outer layer, folded inward, caused by a 30-mm gun. **The inward folds are clearly seen, which are characteristic of this type of projectile.**

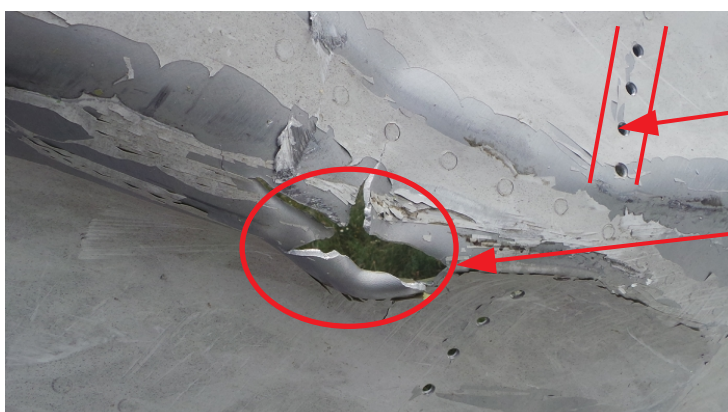
Photo 22. nature of the damage skin Boeing 777
Фото 22. Характер повреждений обшивки Boeing 777

Fragment of Boeing 777.
Taken off the rivet.

Rupture of the fuselage from the inside to the outside edges of the impact blow that is caused by any explosion inside the airplane, or a sharp drop in internal pressure at high altitude
