Analysis of the causes of the crash of Flight MH17 (Malaysian Boeing 777)

1. The Event

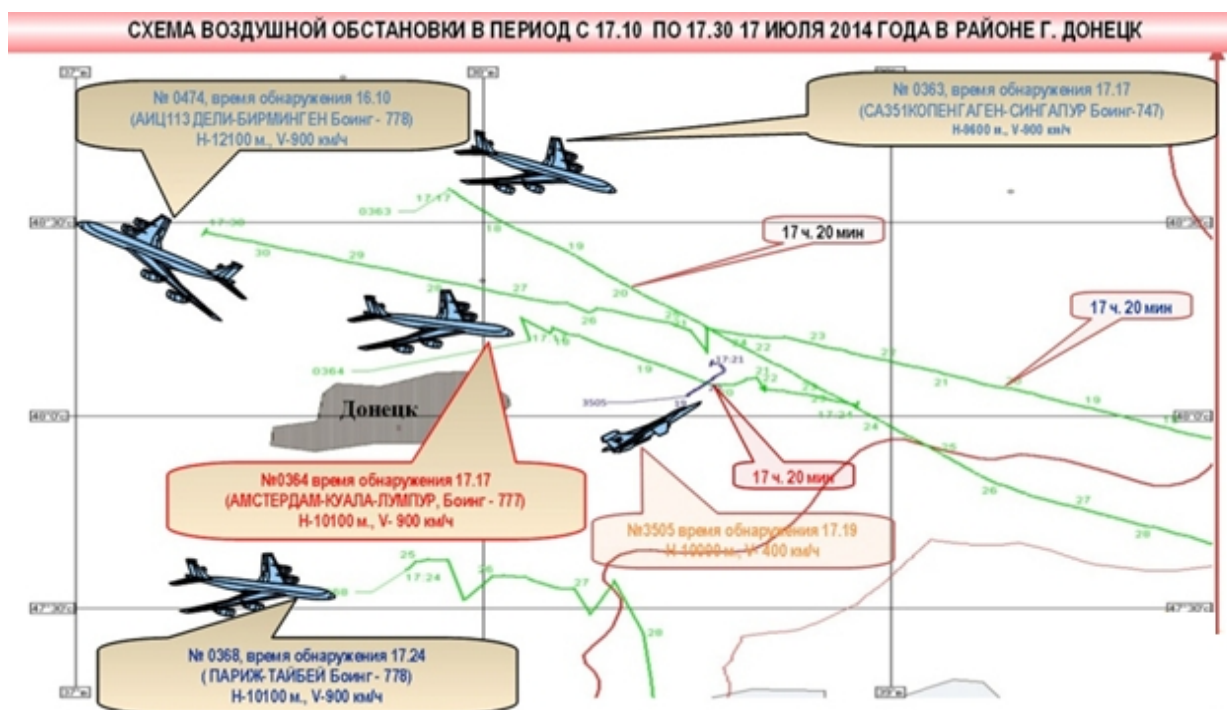
In addition, Russian air traffic control recorded the ascent of a Ukrainian Air Force aircraft, presumably an Su-25, in the direction of the Malaysian Boeing 777. The distance between the SU-25 aircraft from the Boeing 777 was between 3 and 5 km.

Fig.1 Diagram of the situation in the sky in the area where the Boeing 777 was destroyed (according to data from the Russian Federation Ministry of Defense)
